PBY Catalina

Walk Around Number 5
squadron/signal publications

By William Scarborough
Color by Don Greer
Illustrated by Joe Sewell

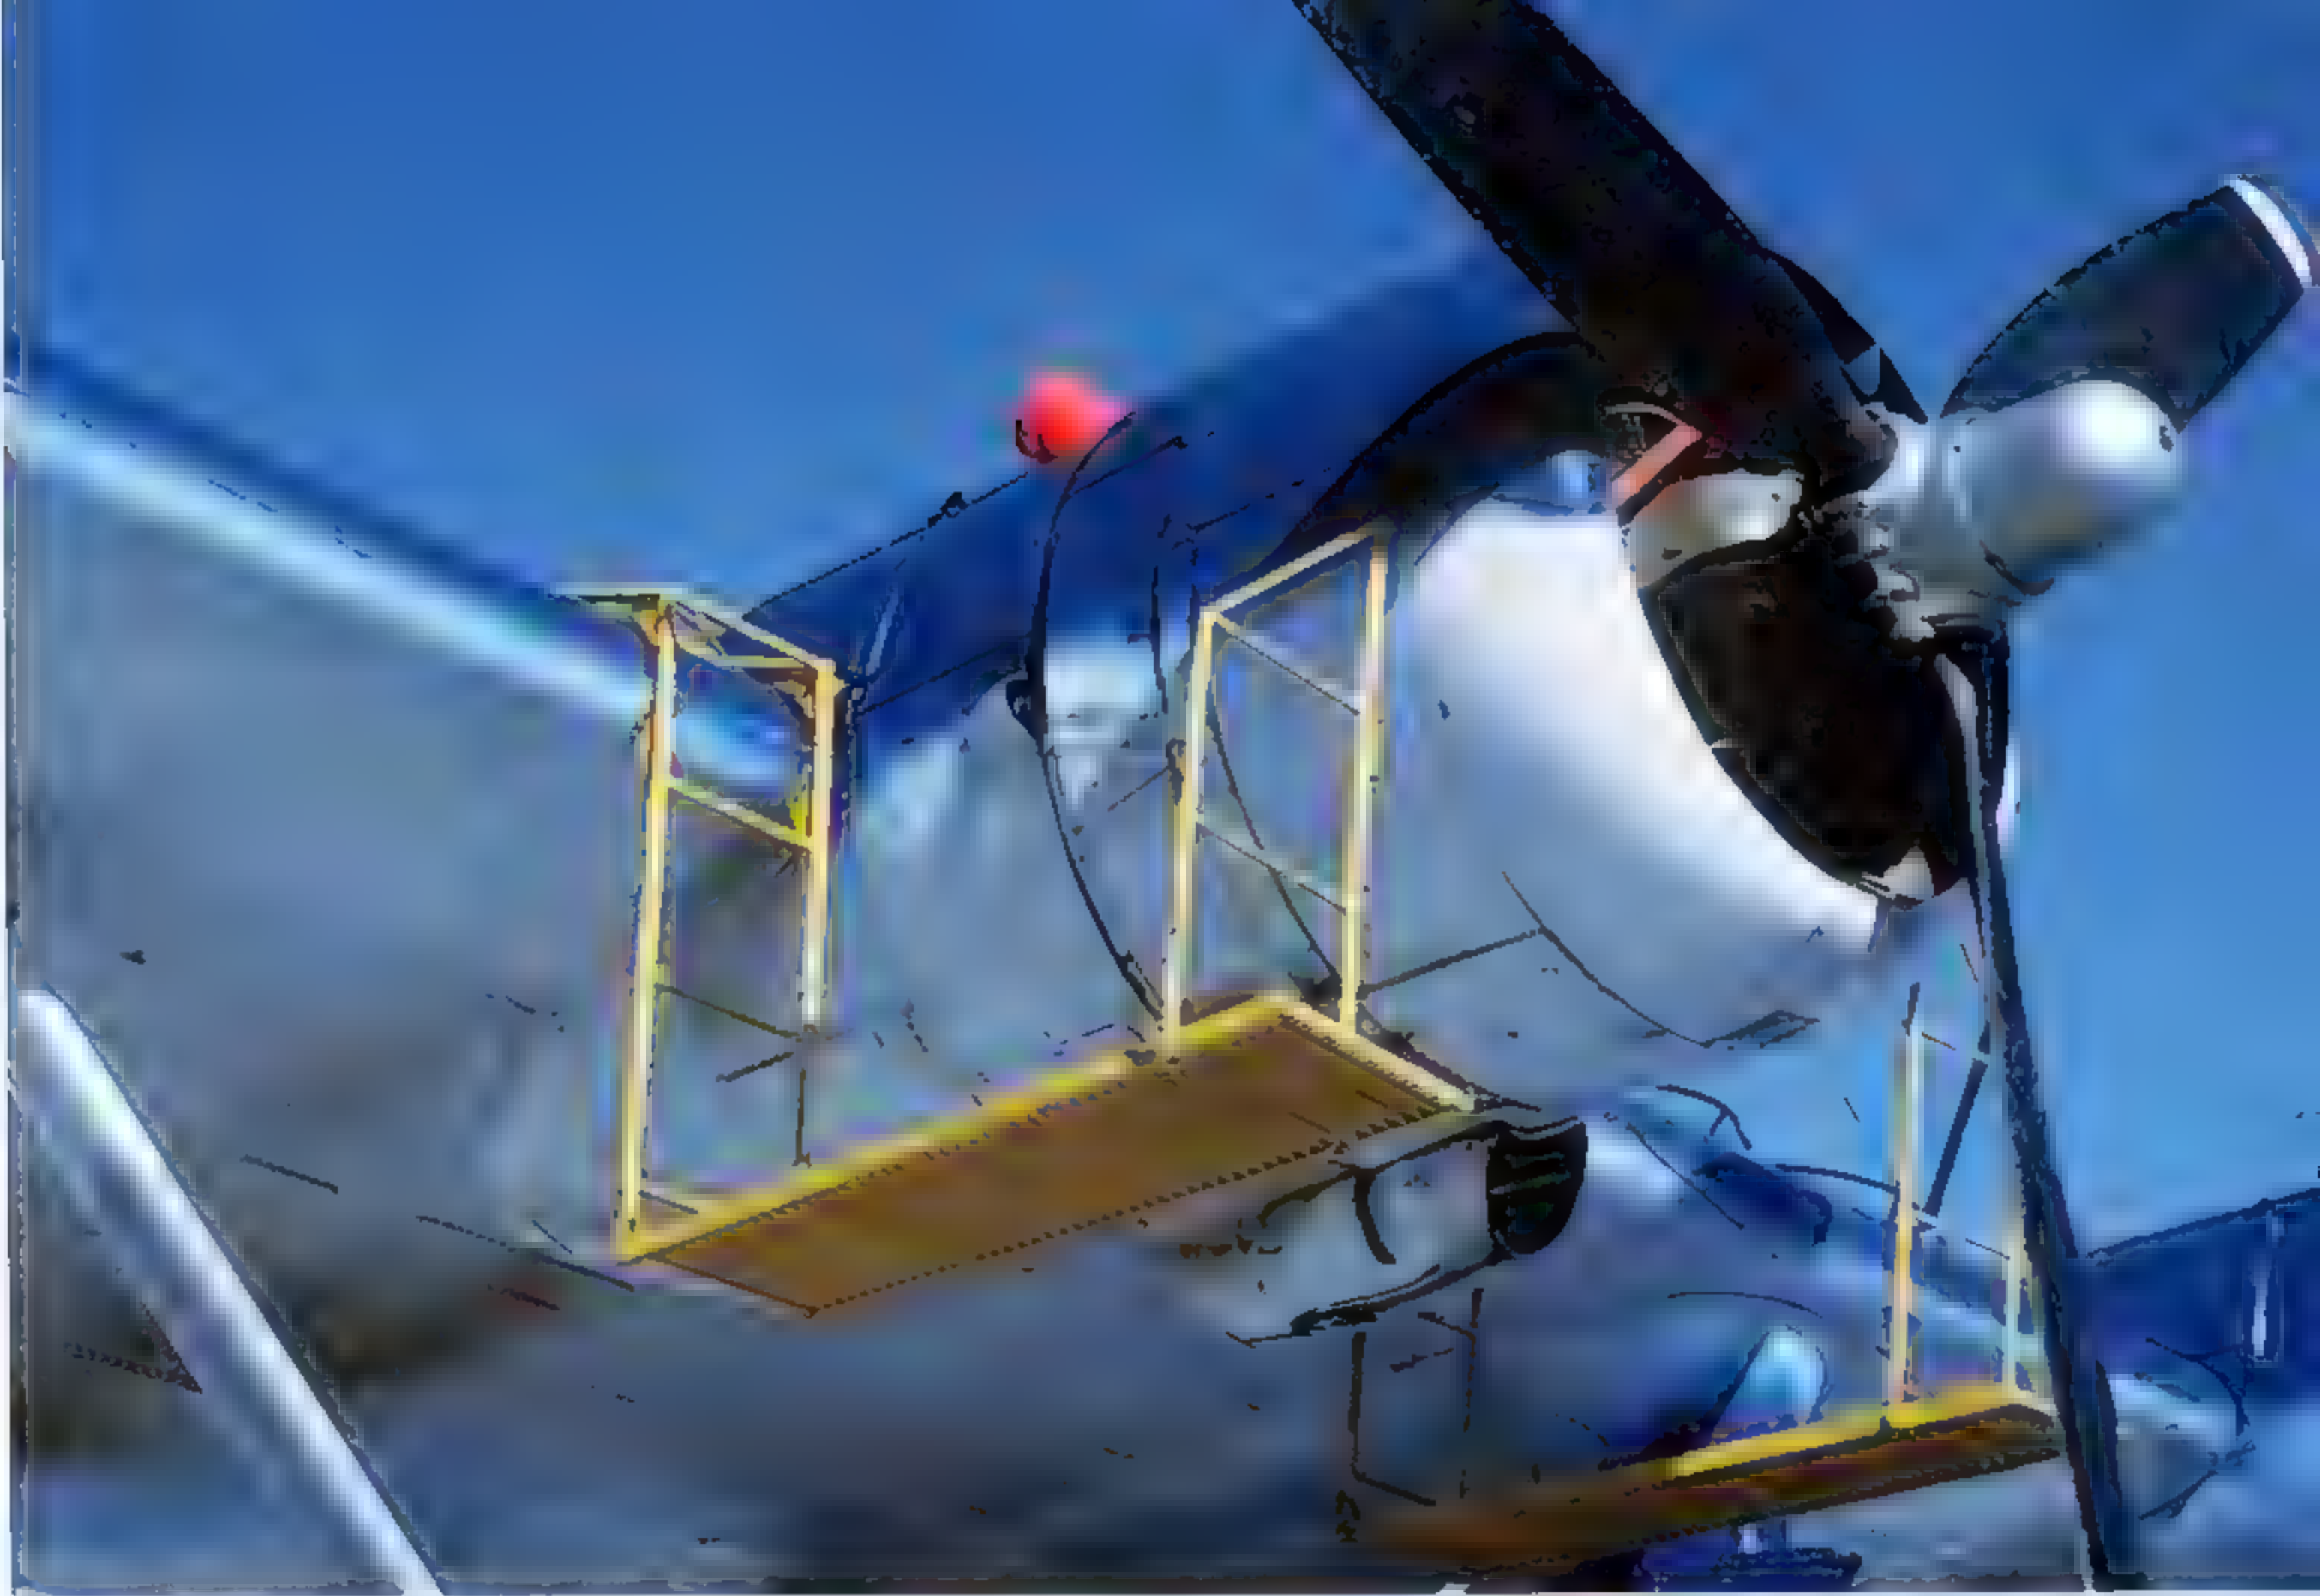
This PBX-6A Catalina is owned by the Confederate Air Force and is powered by Pratt & Whitney R-1830-92 air-cooled radial engines driving twelve foot, three blade Hamilton-Standard constant-speed propellers. The work stands attached into sockets above the wing and in the forward portion of the cowling, allowing maintenance personnel access to the engine. The work stands were normally carried aboard service PBXs stowed in the bunk compartment. (Mark Aldrich)

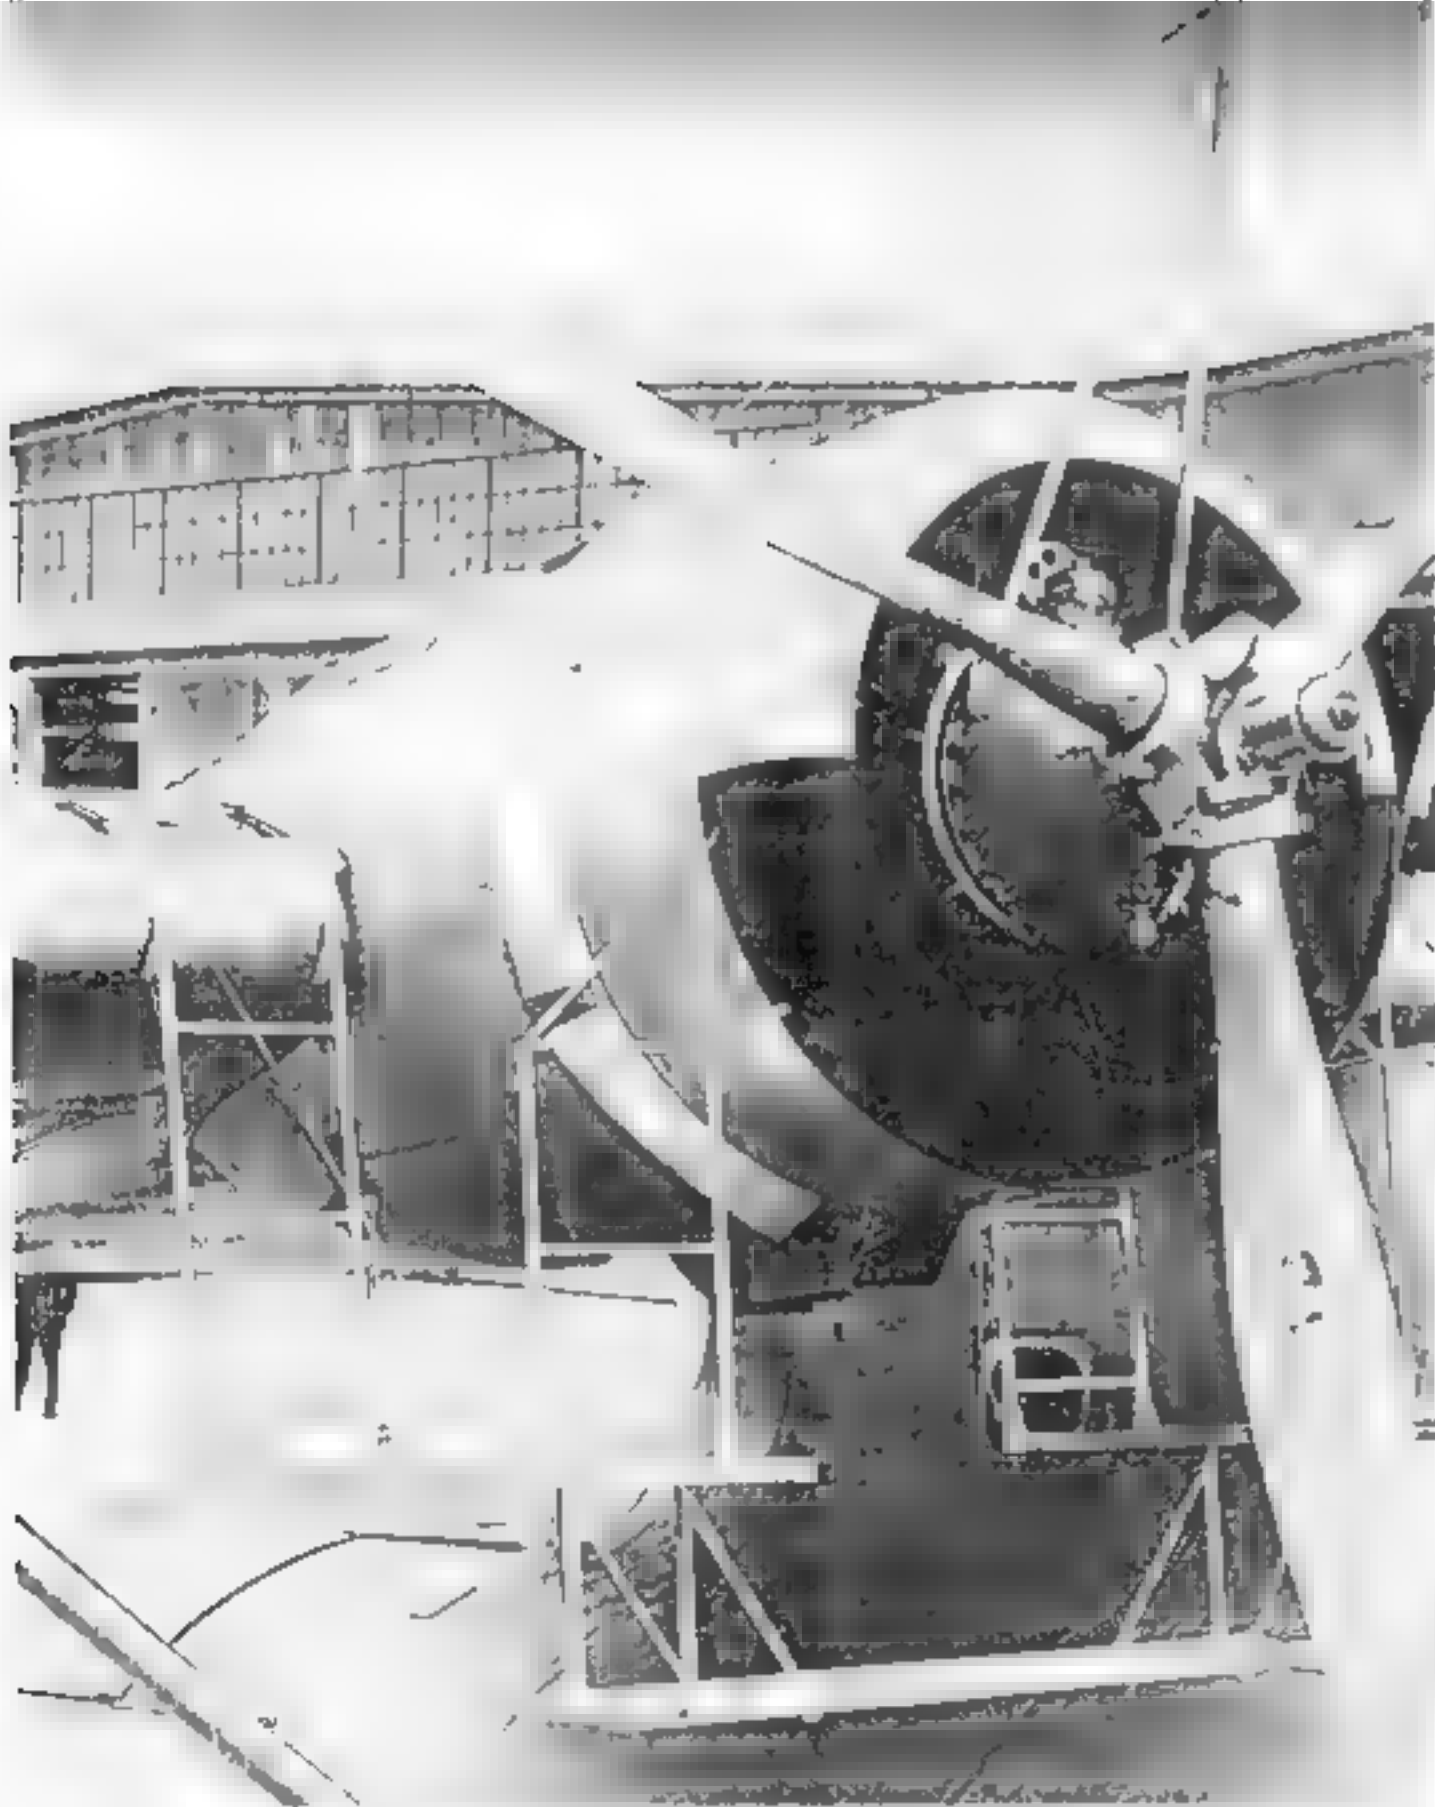
PBY engine work stands in place on each side of the engine nacelle. The V strut above the propeller was a portable propeller hoist used to change propellers in the field. These, like the work stands, were the same for all PBY variants. (USN)

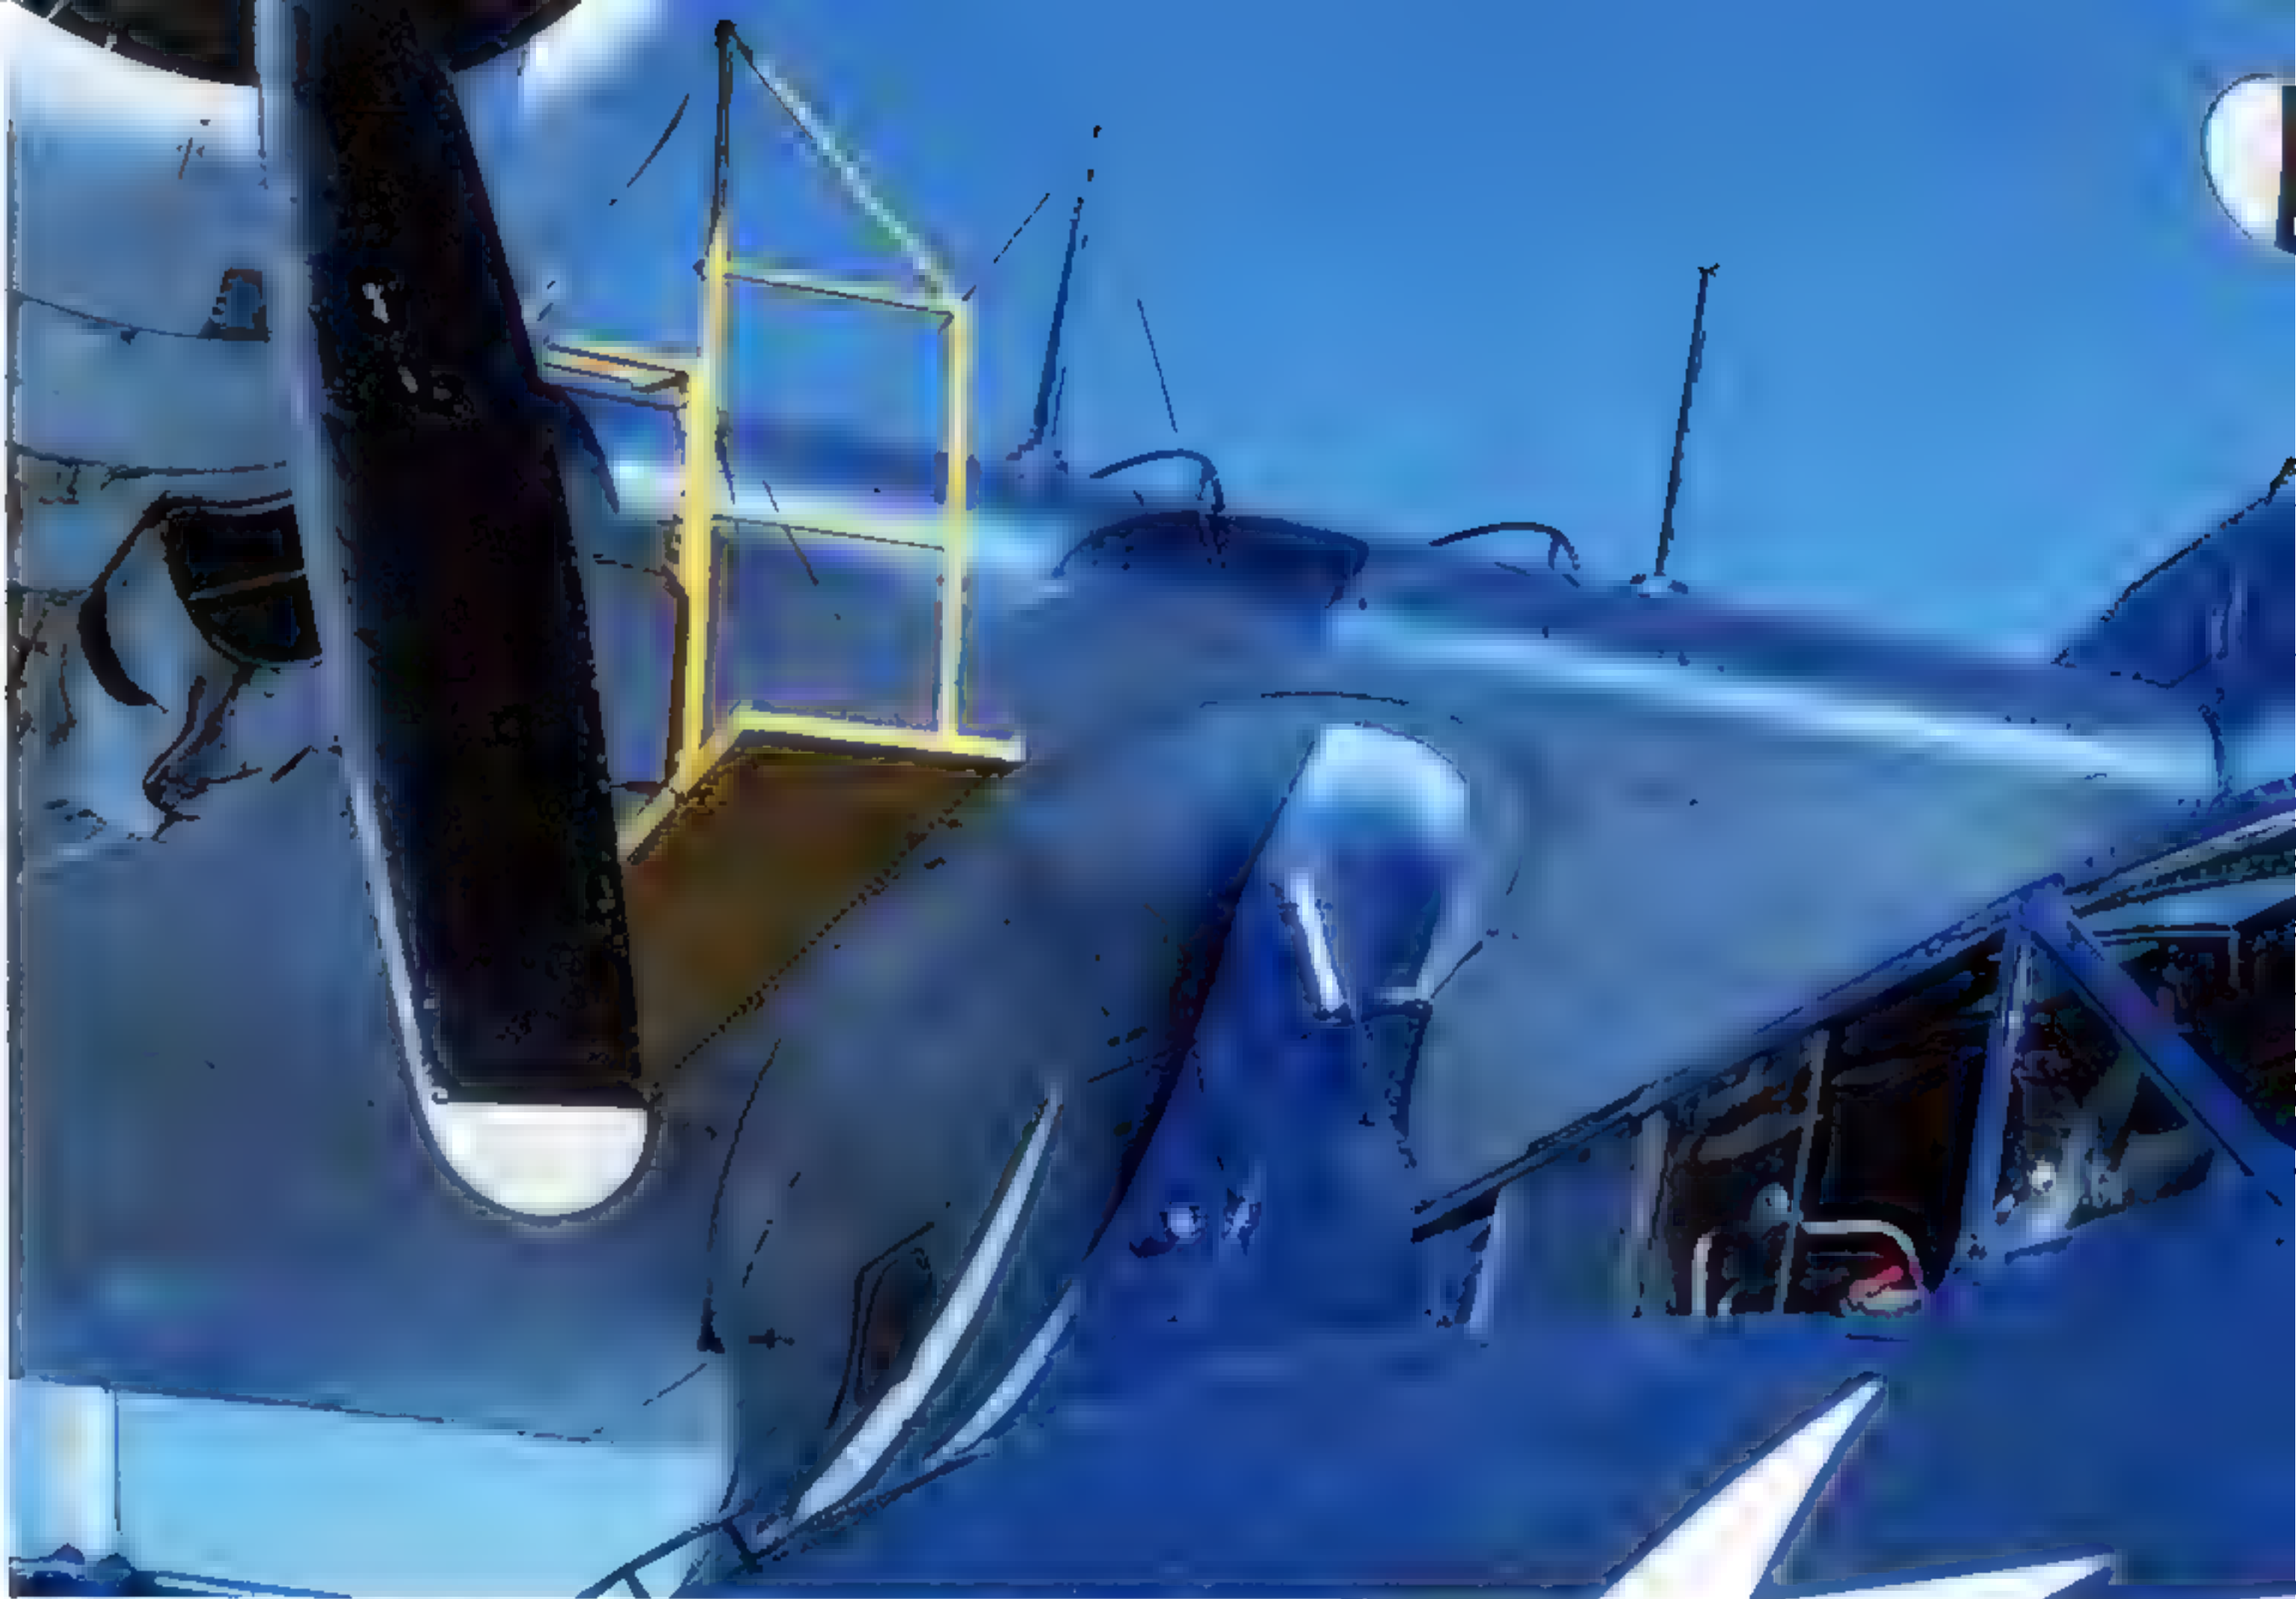
The wing center support pylon was the main support for the massive 104 foot wing. The pylon housed the flight engineer's station with his control panels and equipment. There was a window on each side of the pylon. The ledge half way up the front of the pylon was the pylon step used by personnel to gain access to the top of the wing from the fuselage. This PBY has two non-standard antenna masts on the upper wing along with a pair of non-standard hand holds, probably added by the CAF (Mark Aldrich)

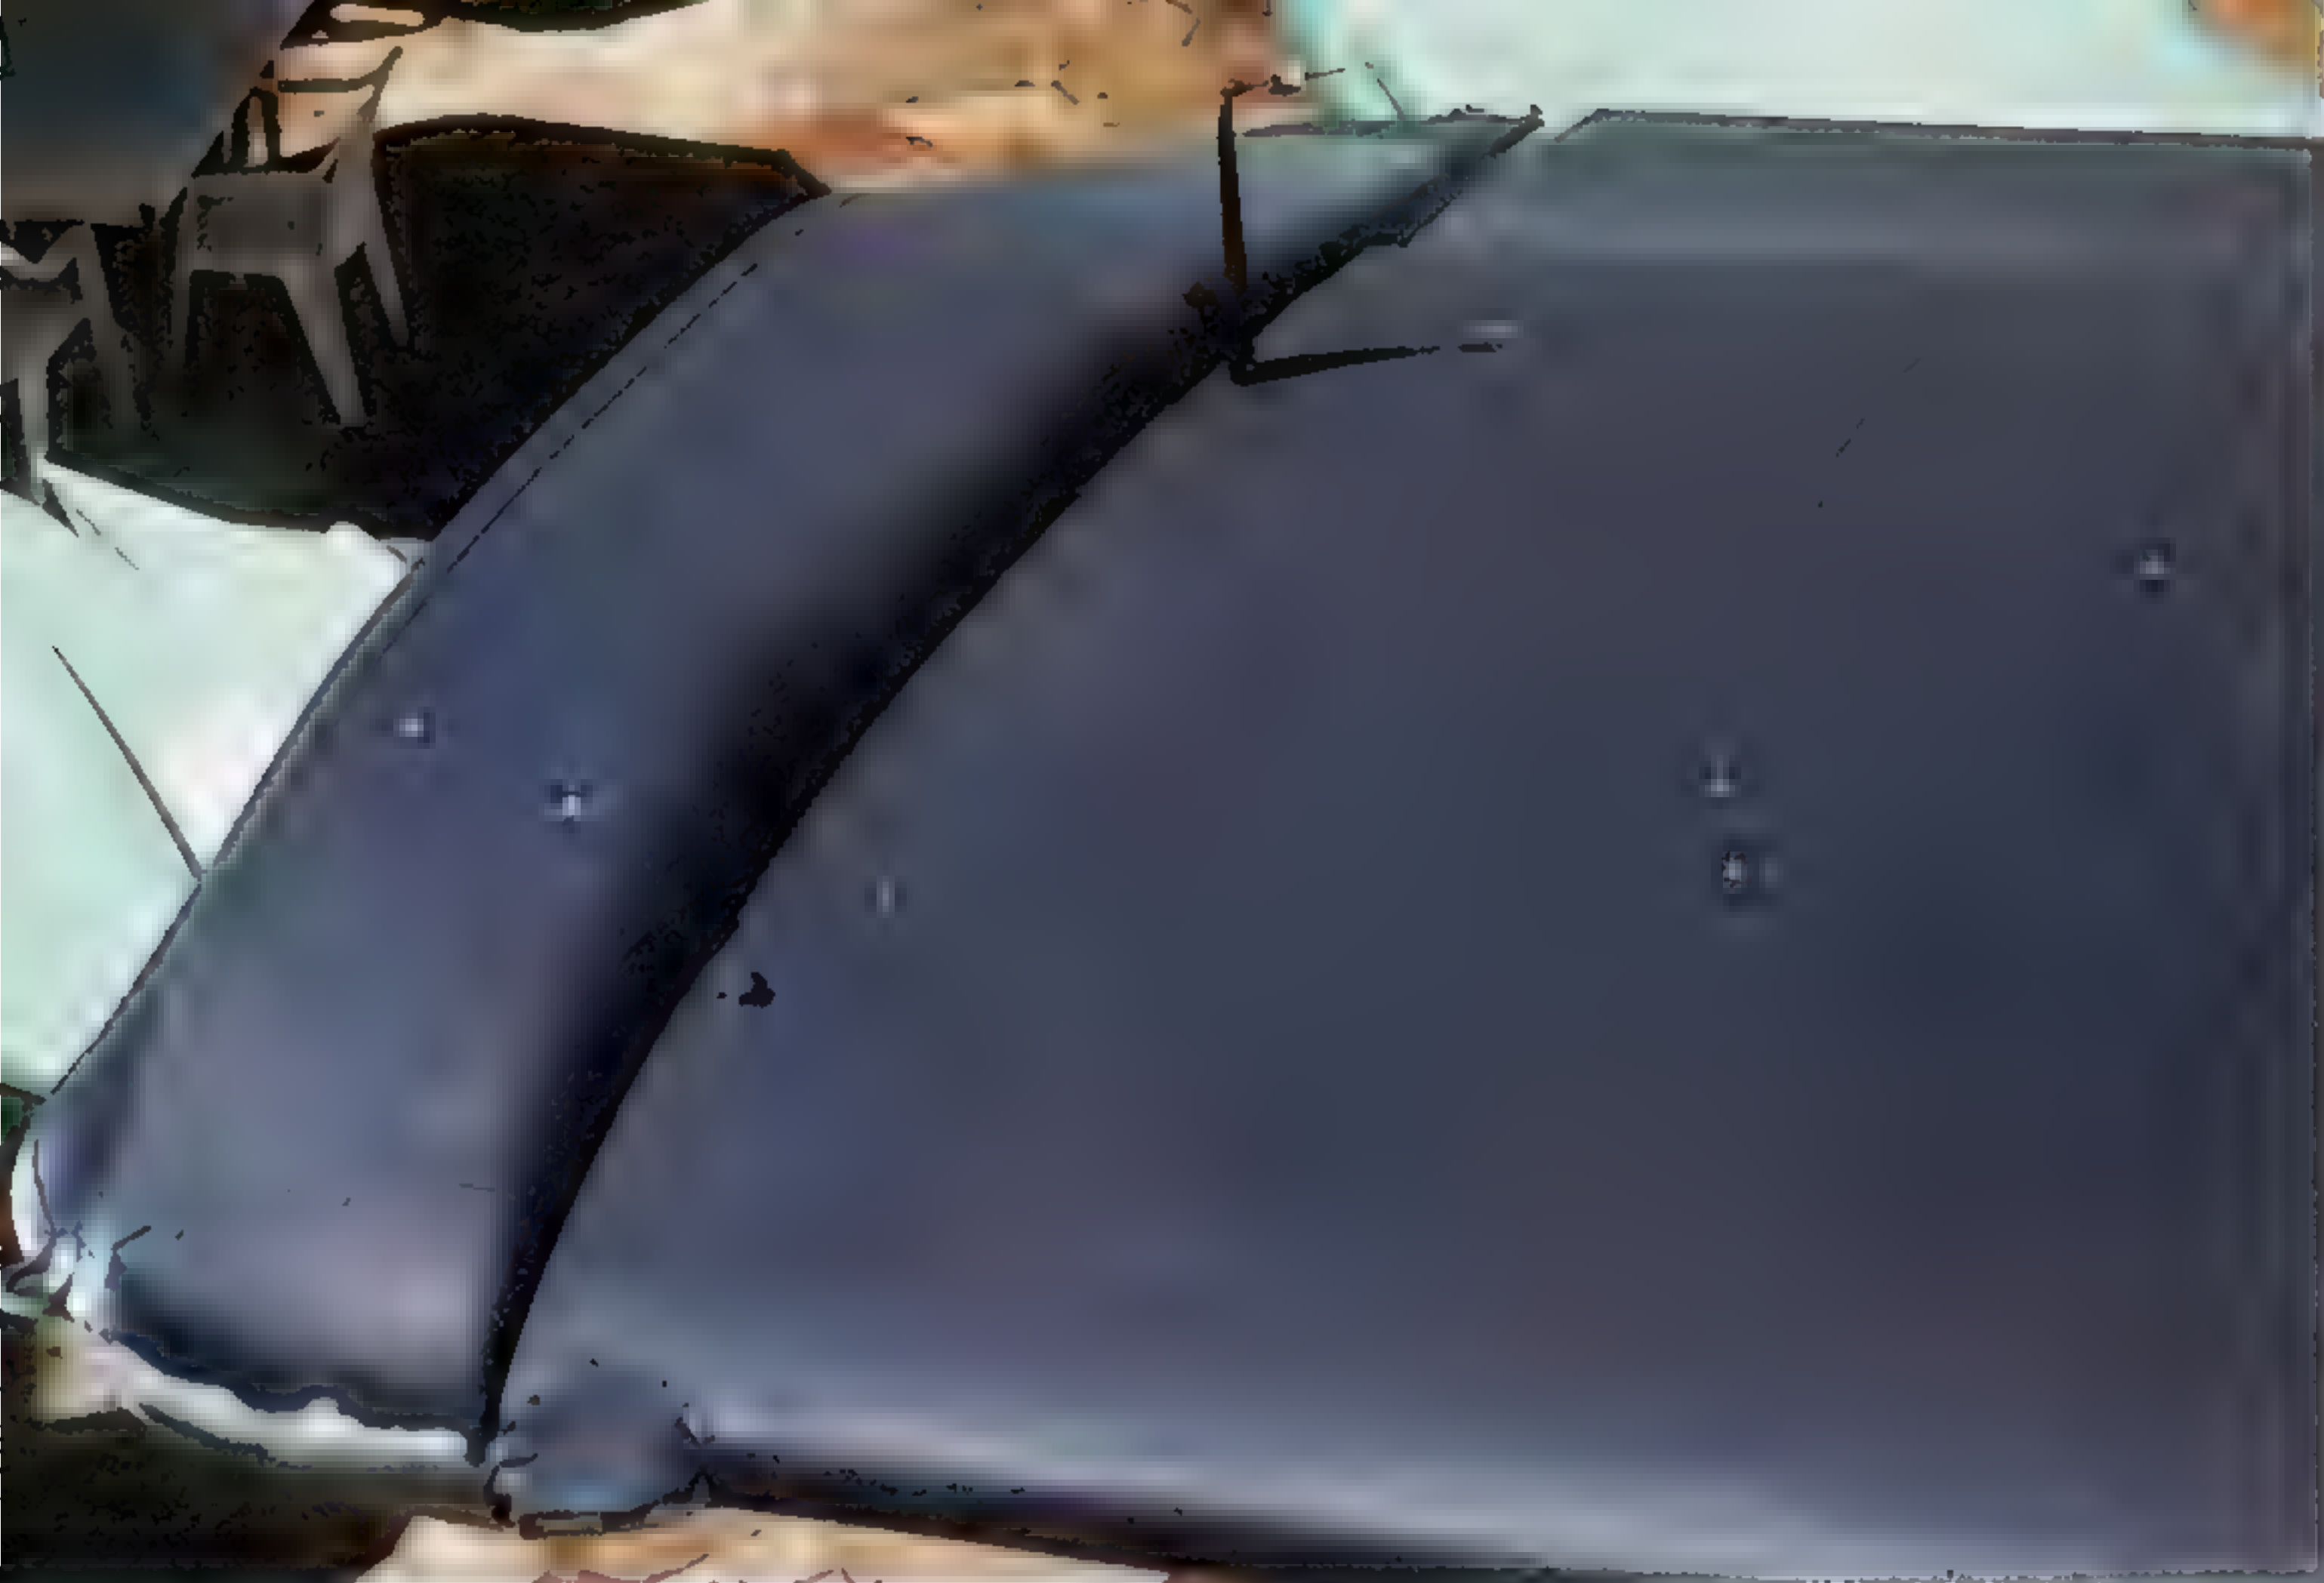
The retractable wing tip floats on the PB4Y-2A at the San Diego Aerospace Museum are in the fully retracted position. The rings on the front and rear of the float were tie down rings. The fairing at the wing leading edge just inboard of the float is the starboard position light, and the post near the wing trailing edge was the wing tip antenna mast. An antenna wire ran from this mast back to the forward leading edge of the vertical fin, while another wire ran from the fin to the opposite wing tip. (Mark Aldrich)

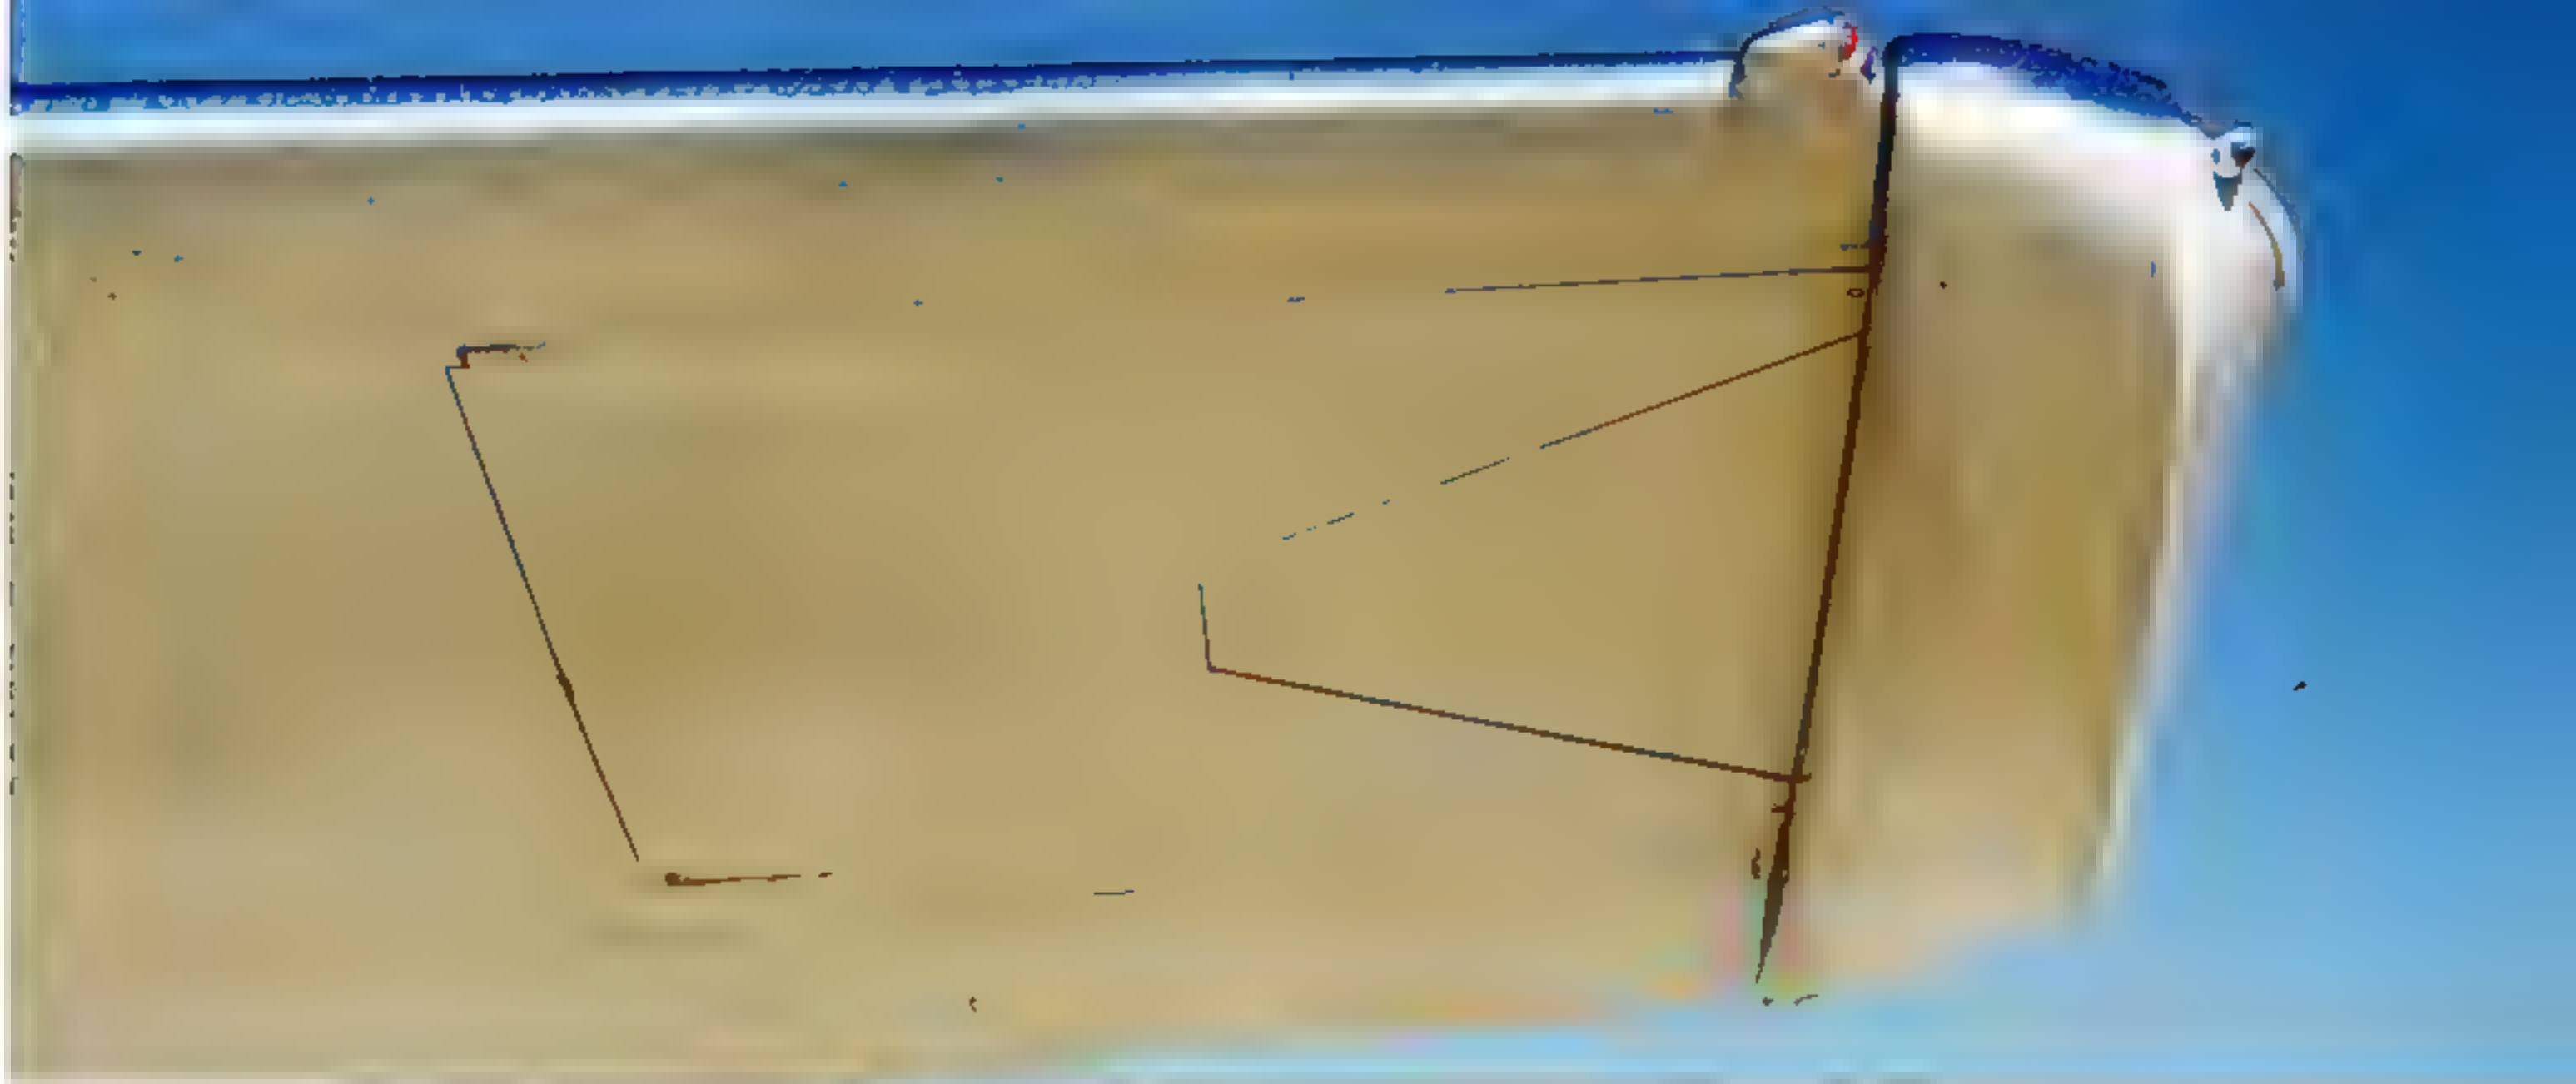
When retracted, the wing tip floats of the PB4Y fit flush with the tip of the wing while the doors fit flush with the underside of the wing. The V shaped section is a structural part of the lower wing surface and not a part of the float. The wing tip navigation light shines forward and outward and is shielded from the cockpit by the light fairing. The ring on the float front is a tie-down ring used to help secure the aircraft. When retracted, the float is held in position by the fully retracted actuating strut. The color demarcation line runs down the center of the float, with areas view from above painted in the upper surface camouflage color and areas viewed from below painted in the lower surface color. The aileron trim tab is also visible along with its actuating push rod. In rough air the floats could be observed flexing up and down. (Mark Aldrich)

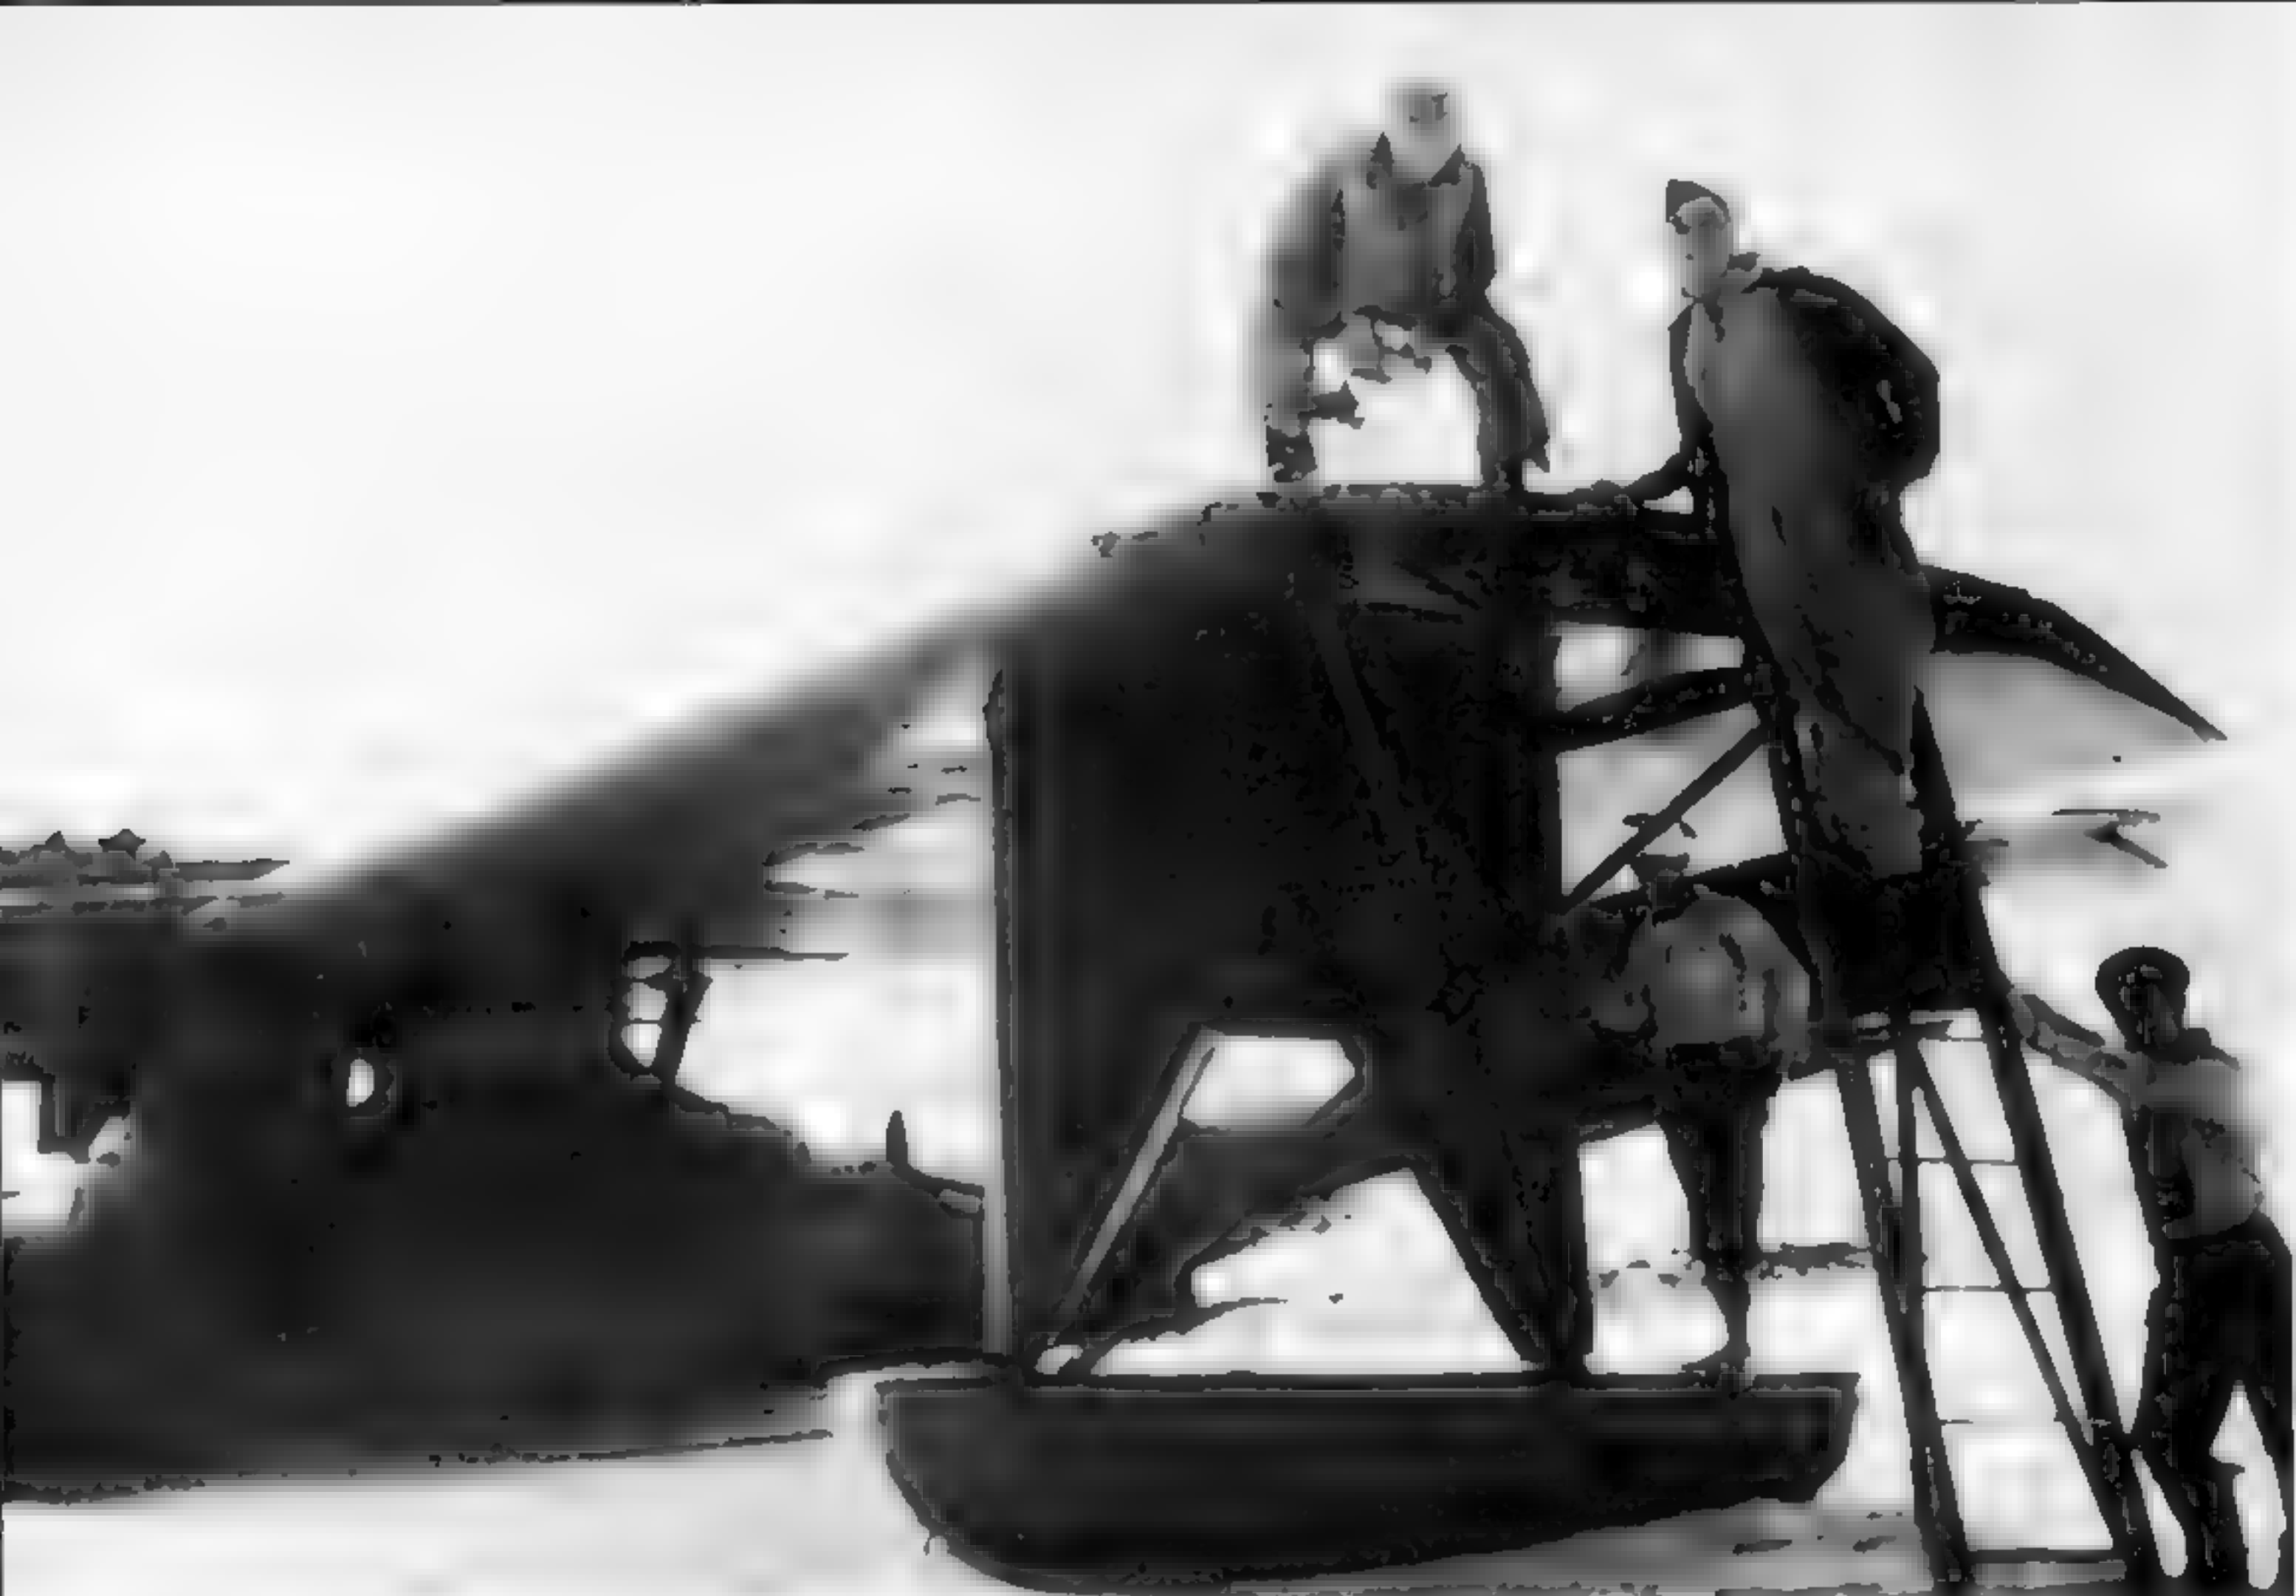
This PB4Y-2, beached on the Naval Air Station Pensacola, Florida, shows one way to change crews between training flights. The wing tip float is in the full down position and is resting on the sand. The X shaped struts are the float actuating and support struts.
